SECONDARY AIR SUPPLY SYSTEM

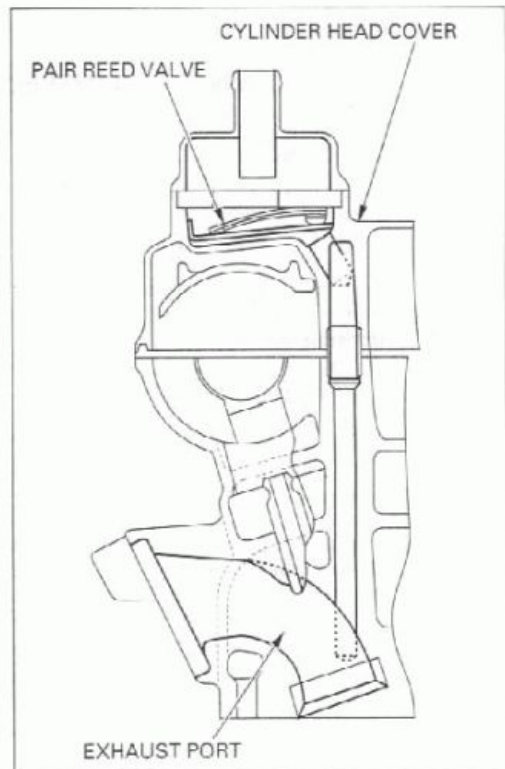
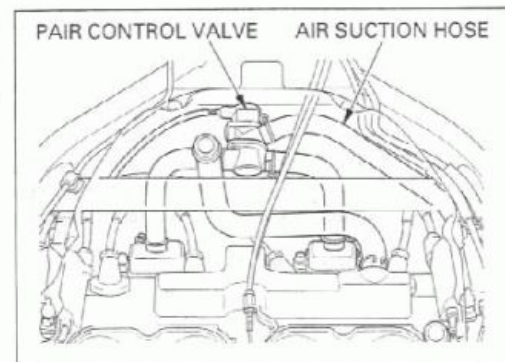
Check the PAIR (Pulse Secondary Air Injection) hoses between the PAIR control solenoid valve and cylinder head cover for deterioration, damage or loose connections. Make sure the hoses are not cracked.

Check the air suction hose between the air cleaner housing and PAIR control solenoid valve for deterioration, damage or loose connections. Make sure the hoses are not kinked, pinched or cracked.

If the hoses show any signs of heat damage, inspect the PAIR check valve in the PAIR reed valve cover for damage.
