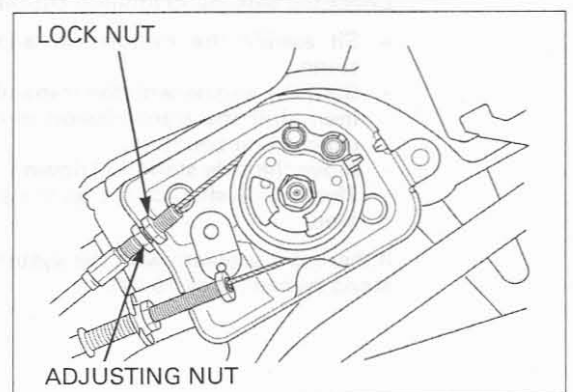
3. Loosen the adjusting cable lock nut and adjusting nut.
4. Adjust the pulley position by turning the adjusting nut.
5. Tighten the lock nut securely.
